PROJECT DESCRIPTION  
WHITE'S RESERVOIR MAINTENANCE – T 11S, R 02E, SEC 9 (#6690)

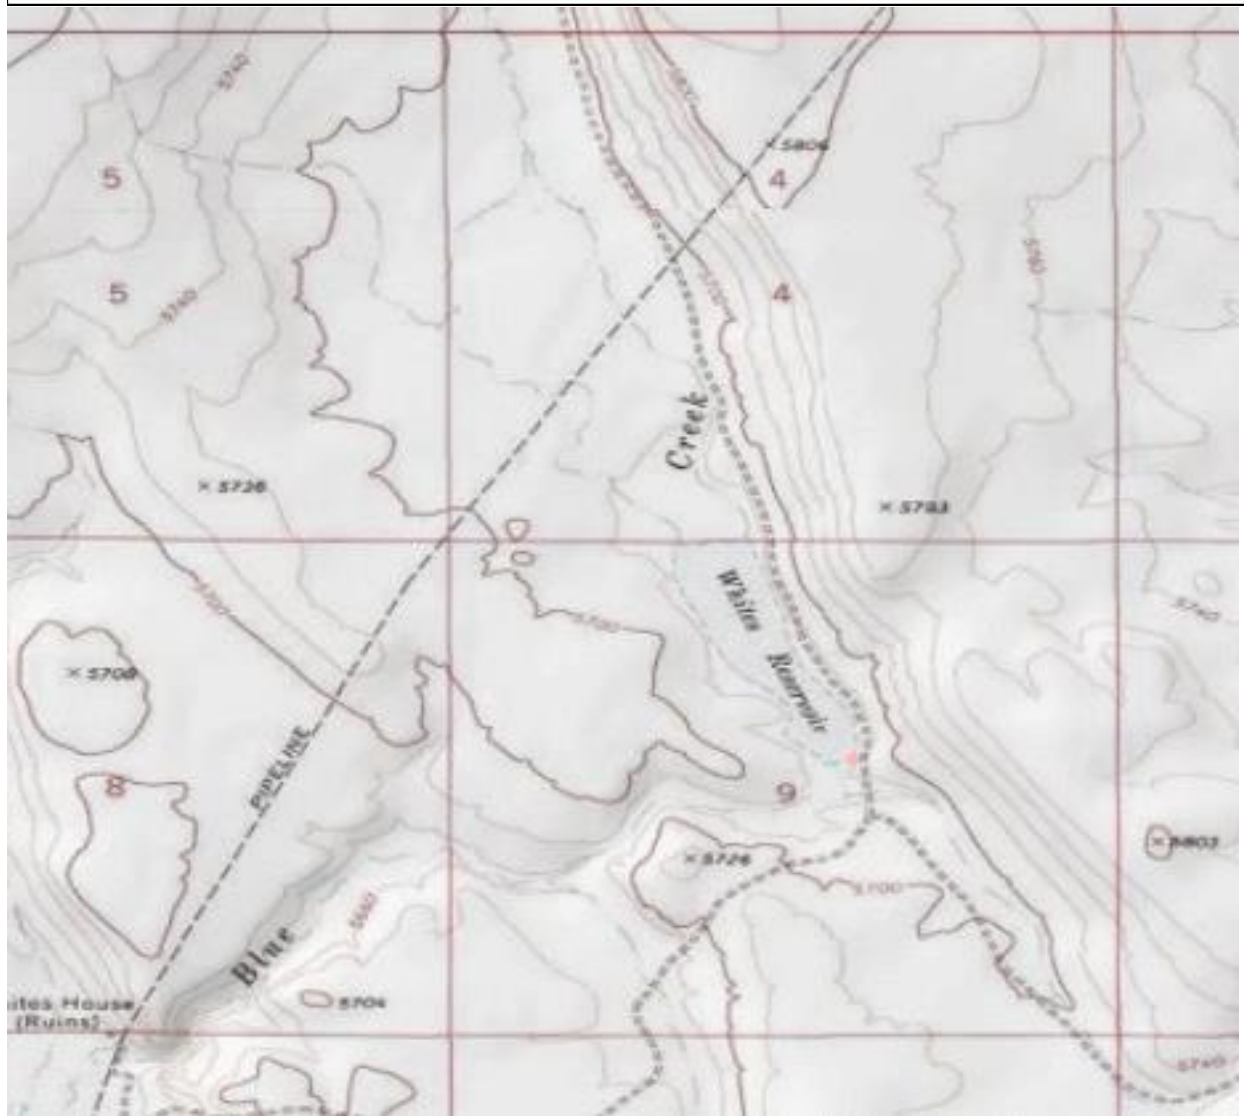
Figure 3. Reservoir Maintenance Location and Access Overview

Maintenance work would be done at the existing reservoir located in the Southwest quarters of the Northeast quarter of Section 9, Township 11 South, Range 2 East. The project map depicts the location of the reservoir and access routes. The equipment operator could access the reservoir from either the eastern or western routes, and walk the dozer in from an unloading point near the main road.

Work would be performed with a bulldozer (Figure 5). Equipment would access the reservoir along an existing but unmapped route from the Wickahoney Road to the southeast (Figure 1). The bulldozer would be transported on a low boy trailer to a staging area along the Wickahoney Road. The operator would then drive the bulldozer along the remainder of the route to the reservoir. The probable area of surface disturbance at the reservoir maintenance site at the base of the dam would total approximately 3 acres. The dimensions of the finished project would retain up to -- acre feet per year of surface water, per the terms of the associated water right (water right has to be retrieved from Idaho DWR because RIPS and project files have been deleted for the reservoir itself).

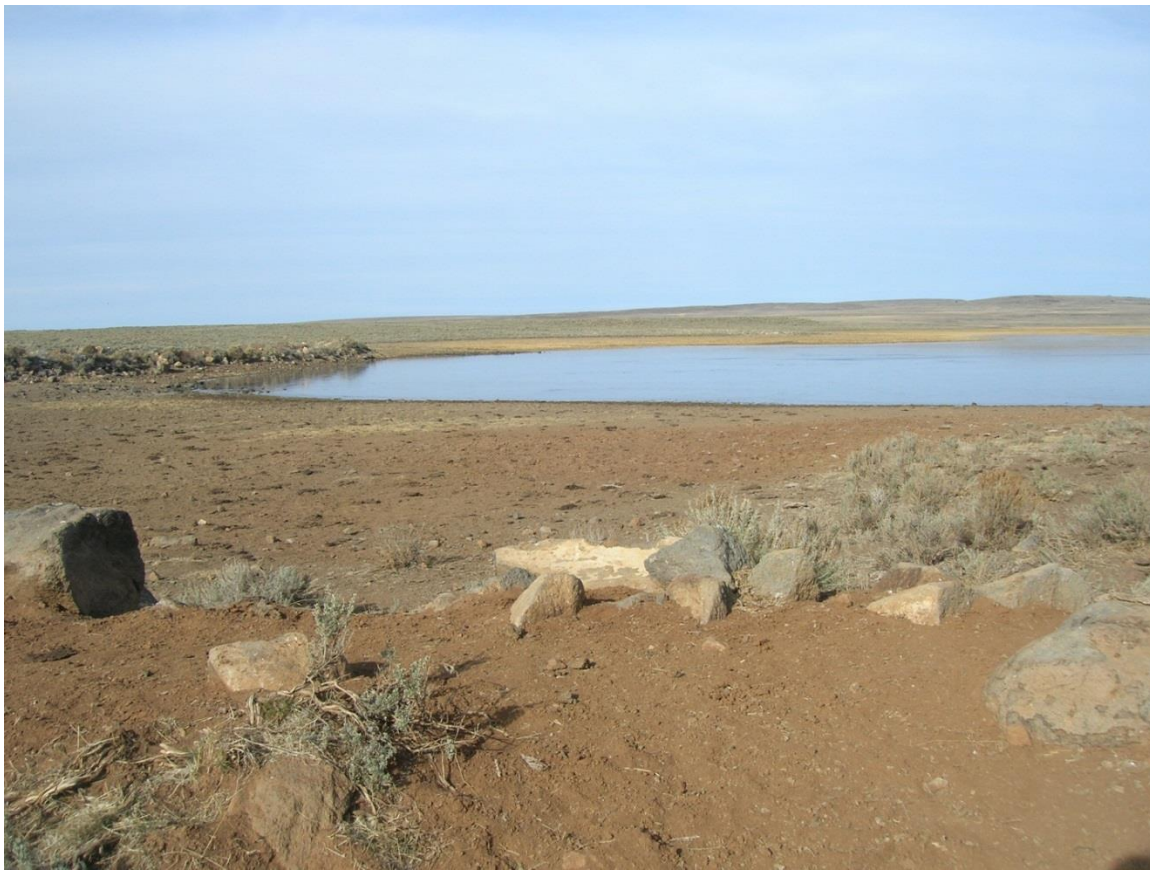
**Figure 2.** White's Reservoir on November 3, 2011. High snowpack, precipitation year.

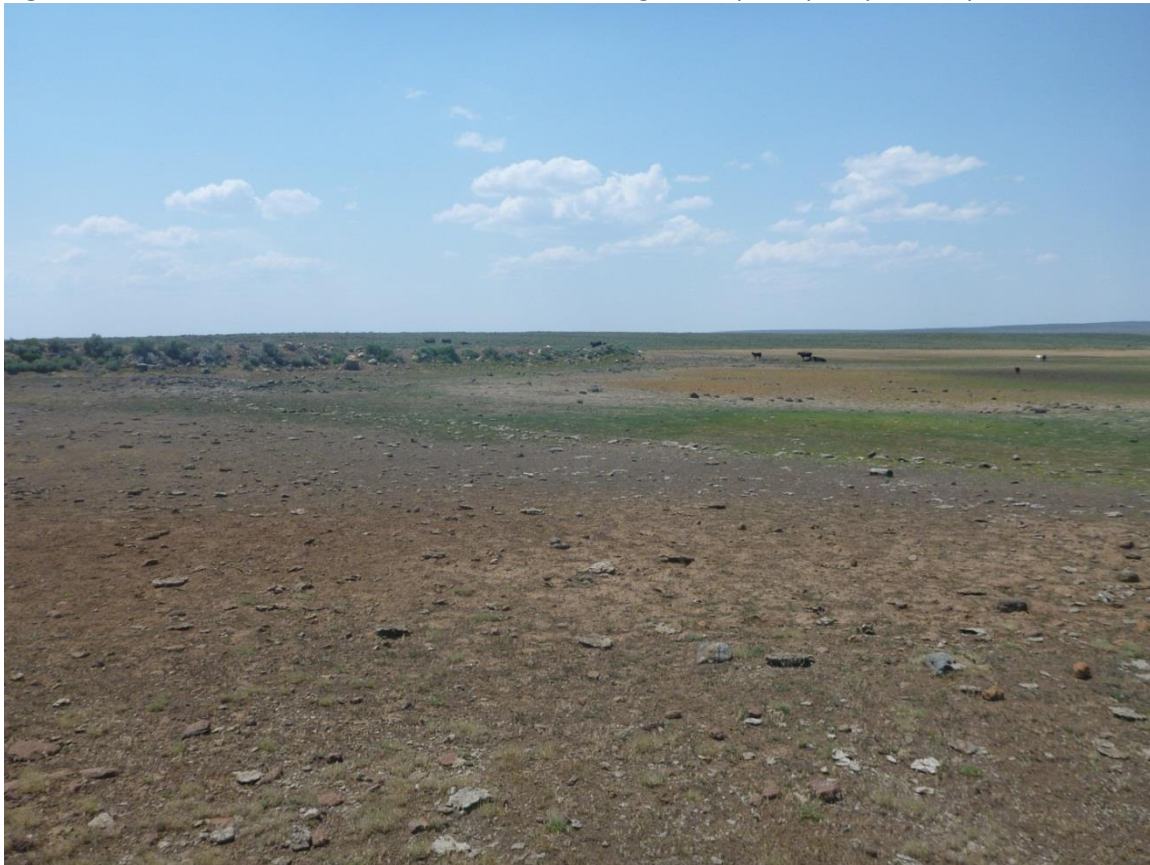
**Figure 3.** White's Reservoir on July 2, 2013. Focus of cleanout in pit immediately behind dam. May have had water early in 2013, none available during period of use.

Maintenance activities would include removing sediment from the reservoir backwater using a bulldozer to displace the sediment. The sediment would be pushed out of the ponding area at the base of the dam and spread out and pushed on to the berm. All earth work would occur in areas previously disturbed by impoundment construction. Care would be taken to avoid breaking the seal in the excavation area, in particular, to avoid the need to use bentonite to reestablish the seal. Bentonite is absorbent clay consisting mostly of Montmorillonite. The extent of the disturbed area would not exceed 5 acres.

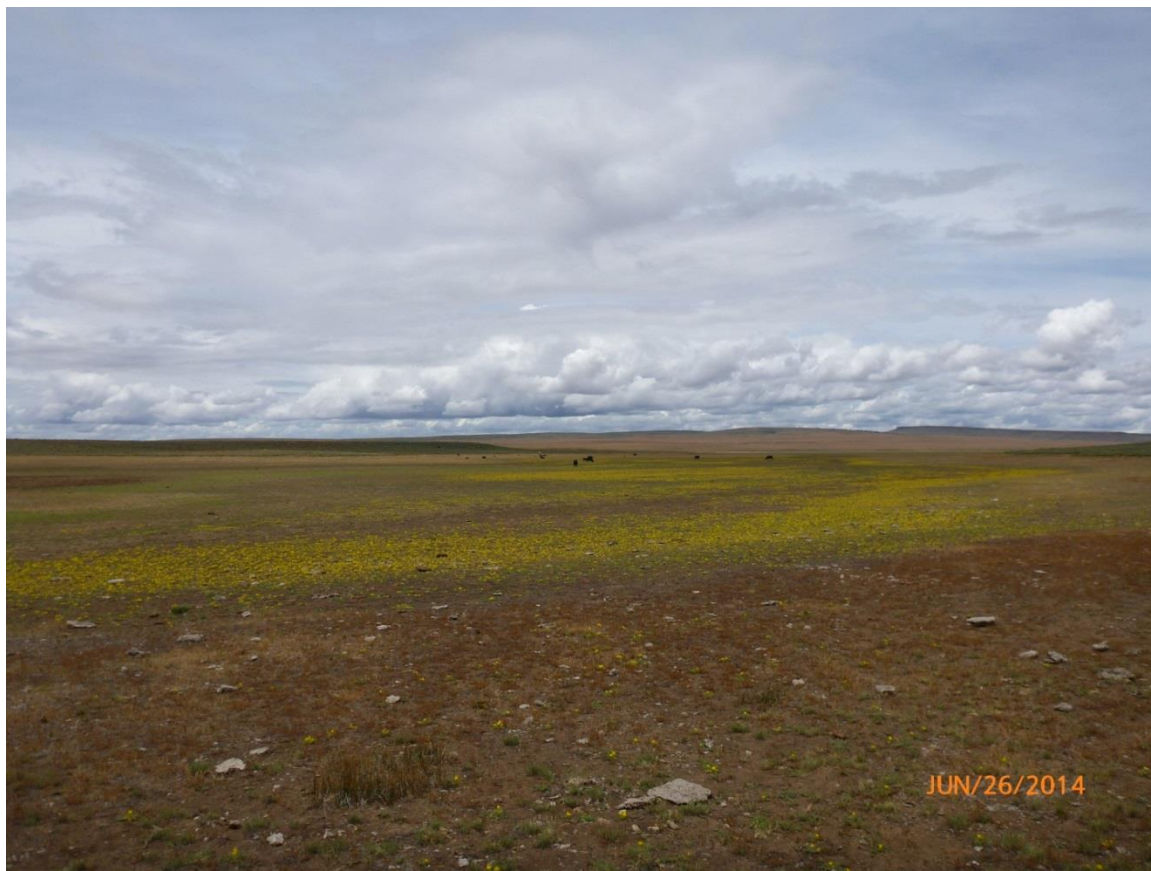
**Figure 4.** White's Reservoir on June 26, 2014. Ponding area completely dry.

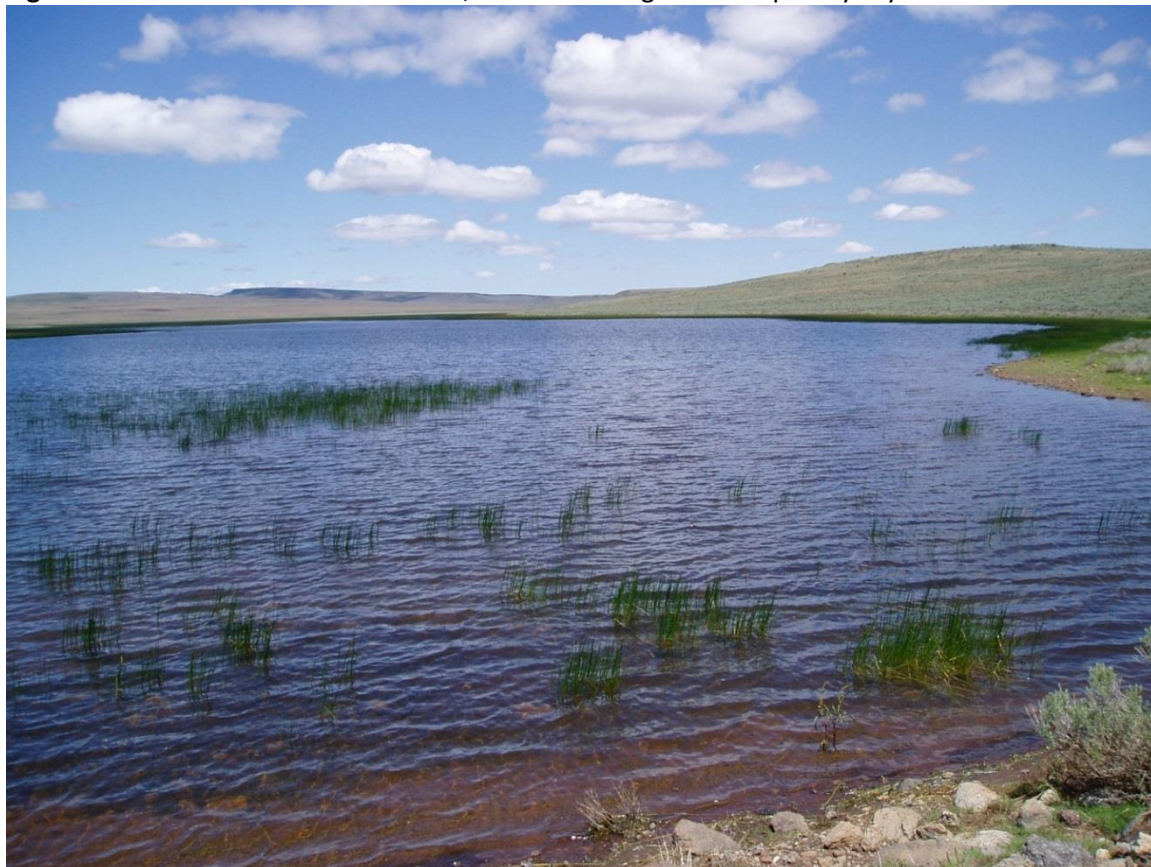
**Figure 4.** White's Reservoir on June 16, 2006. Ponding area inundated in years of average or greater snowpack, with emergent vegetation.

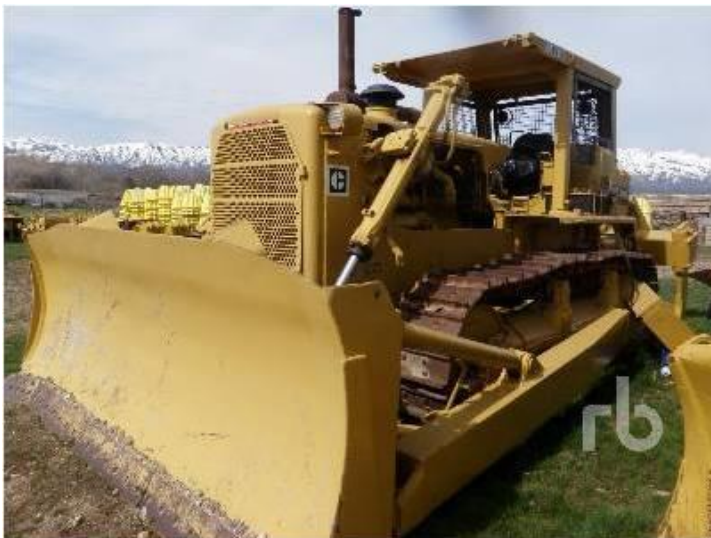
**Figure 5.** Example of Bulldozer (D8)
